DEPARTMENT OF TRANSPORTATION

Contract #: 04-0120F4Cty: SF/ALA Rte: 80 PM: 13.2/13.9File #: 1.28**WELDING INSPECTION REPORT****Resident Engineer:** Casey, William**Address:** 333 Burma Road**City:** Oakland, CA 94607**Report No:** WIR-027878**Date Inspected:** 01-Jul-2012**Project Name:** SAS Superstructure**OSM Arrival Time:** 700**Prime Contractor:** American Bridge/Fluor Enterprises, a JV**OSM Departure Time:** 1530**Contractor:** American Bridge/Fluor Enterprises, a JV**Location:** Job Site**CWI Name:** As noted below**CWI Present:** Yes No**Inspected CWI report:** Yes No N/A**Rod Oven in Use:** Yes No N/A**Electrode to specification:** Yes No N/A**Weld Procedures Followed:** Yes No N/A**Qualified Welders:** Yes No N/A**Verified Joint Fit-up:** Yes No N/A**Approved Drawings:** Yes No N/A**Approved WPS:** Yes No N/A**Delayed / Cancelled:** Yes No N/A**Bridge No:** 34-0006**Component:** SAS OBG**Summary of Items Observed:**

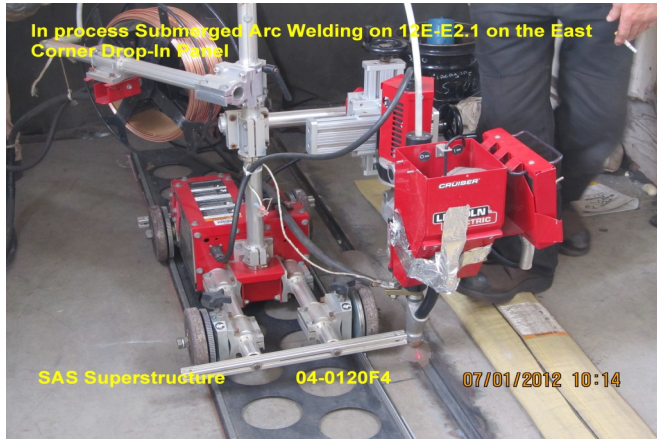
This QA Inspector randomly conducted fit up and measurement of the 12E Corner Drop-In Panel on the interior of the OBG. QC Inspector Salvador Merino utilized a Bridge Cam gauge to measure the planar offset of the 12E-E2.1-C1 seam located on Side Plate "C", and 12E/13E -B1, on Edge Plate "B" on the exterior of the OBG. The work at this location is in progress and appeared to be in general conformance with the contract specifications.

This QA Inspector discussed the offset of 12E-E2.1-C with Quality Control Inspector Salvador Merino.
